## PEDESTRIAN SAFETY WALK

**MONDAY 17<sup>TH</sup> AUGUST 2026 10AM FROM RECTORY GARDENS**

**Route:** Thames Road, Ridgeway path, Cleve Road, Mill Road, Wallingford road up to Primary School and back, Elvendon Road, Footpath to Bourdillon, and along past Milldown up to Lockstile Way, alleyway to Farm Close, back to Wallingford Road, across over the railway bridge onto High Street, about 1.8 miles.

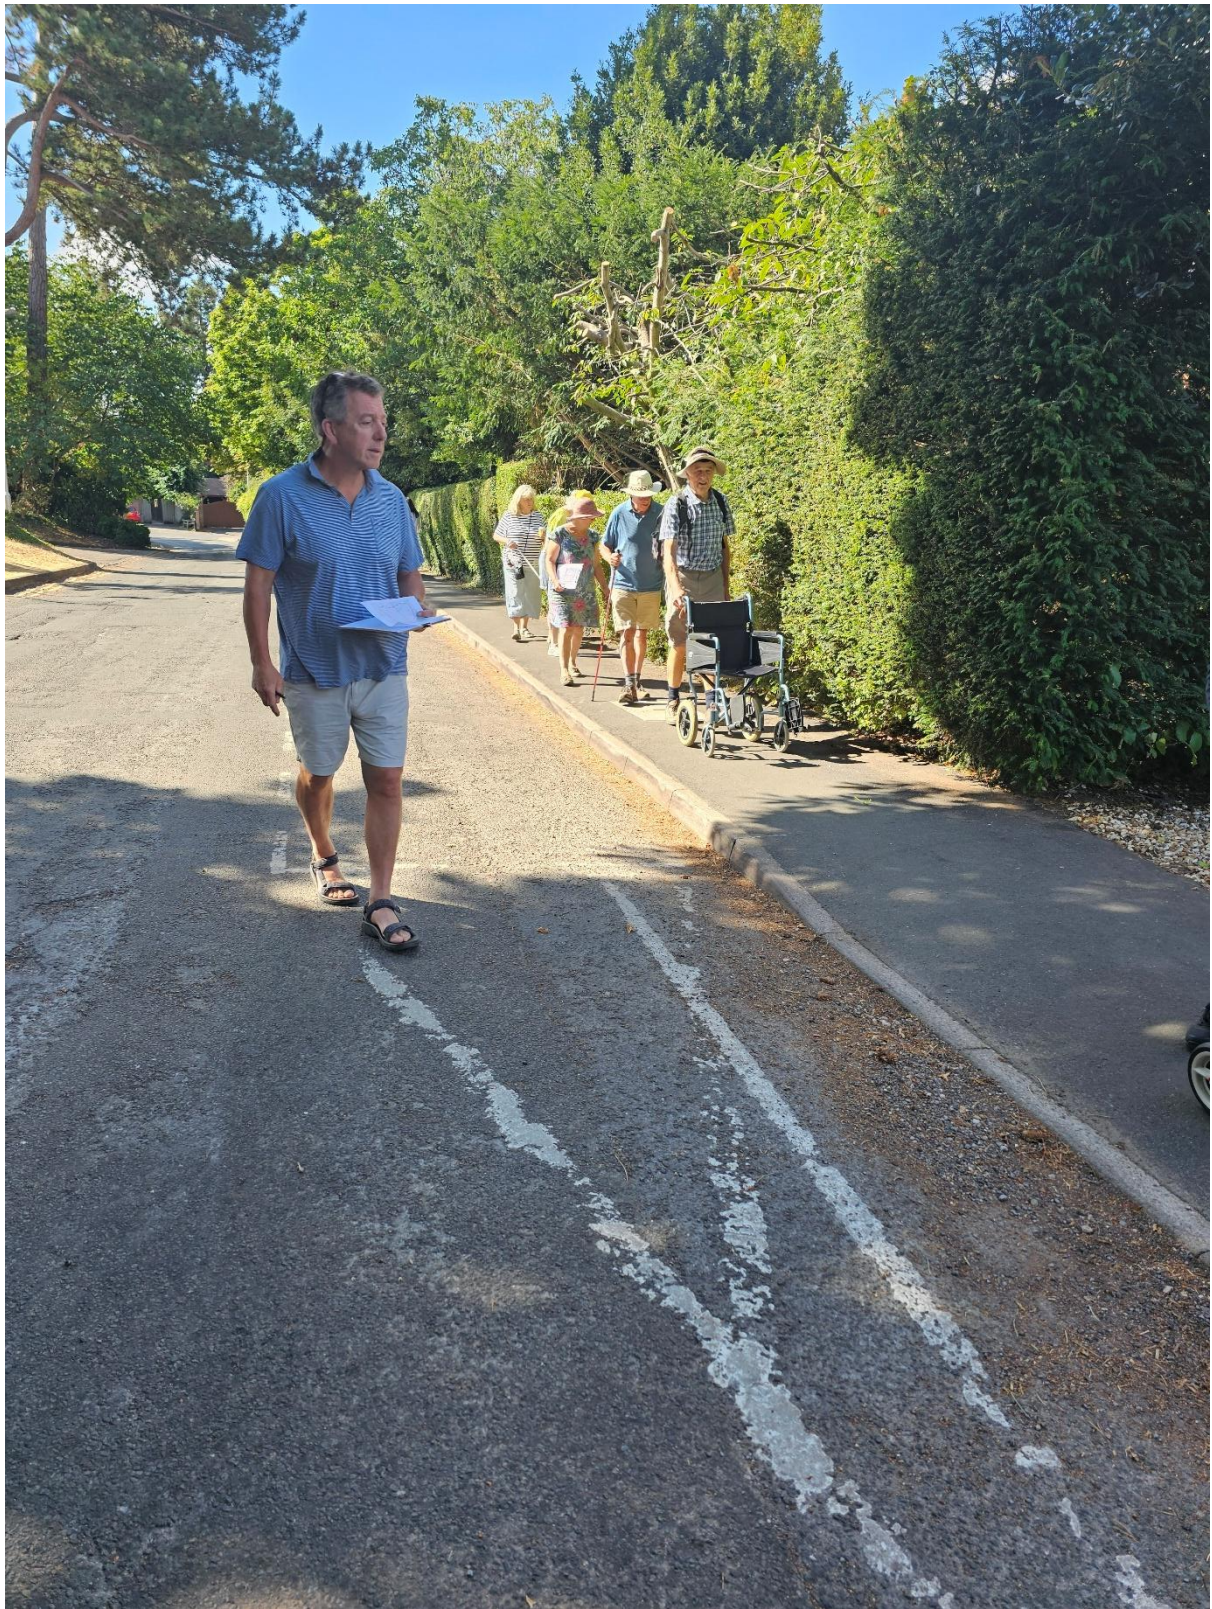
**Thames Road corner with Glebe Ride** – no safe, dropped kerb crossing to Glebe ride from Thames Road, which has no pavement on the left heading east. It is necessary to walk on the left of Thames Road due to lack of pavement but Glebe Ride pavement is on the right. Needs a buildout and dropped kerb.

Pavement along **Thames Road** had slopes that made continuing along uneven. Overgrown hedges on left and parked cars on right are making the pavement very narrow, .

- At junctions use raised tables to make it clear how to cross and alert drivers, and to slow down approaches, plus it solves dropped kerb issue. (Especially for Red Cross and Upper Red Cross Road, Thames Road, and Manor Road junctions).
- Pedestrian priority lanes for Cleeve Road, Mill Road and sections of the High Street to guide drivers where they are to give way to pedestrians under all circumstances.

Better dropped kerbs that actually reach street level/build outs to avoid sloping pavement.

Addition of dropped kerbs in places.

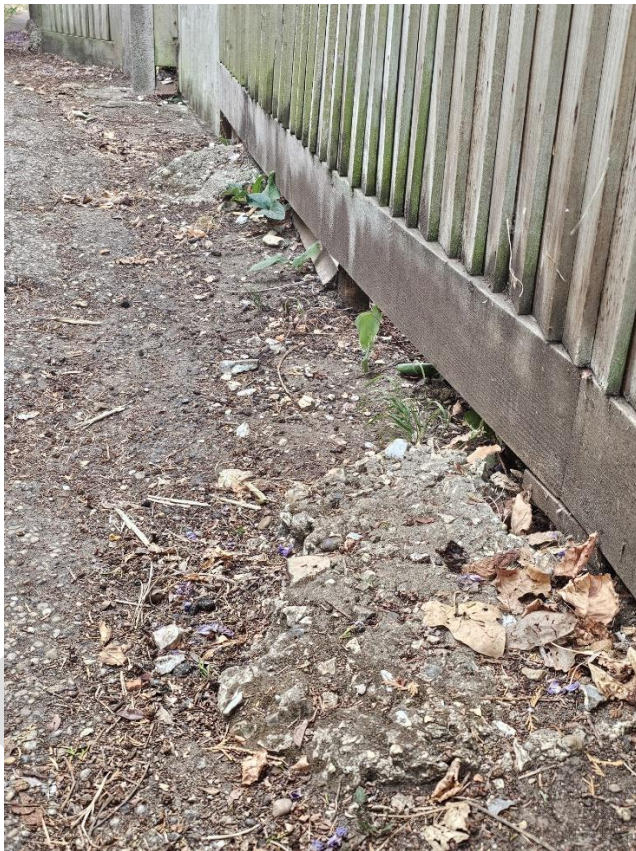
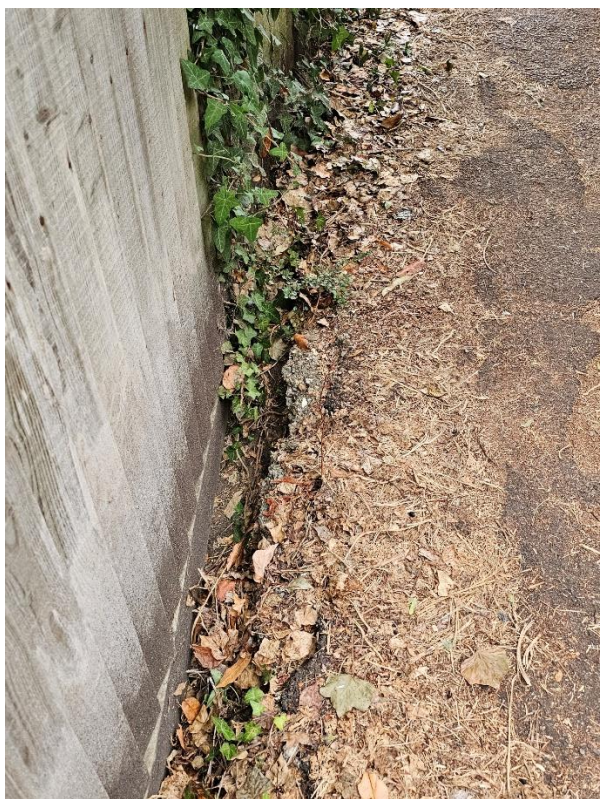
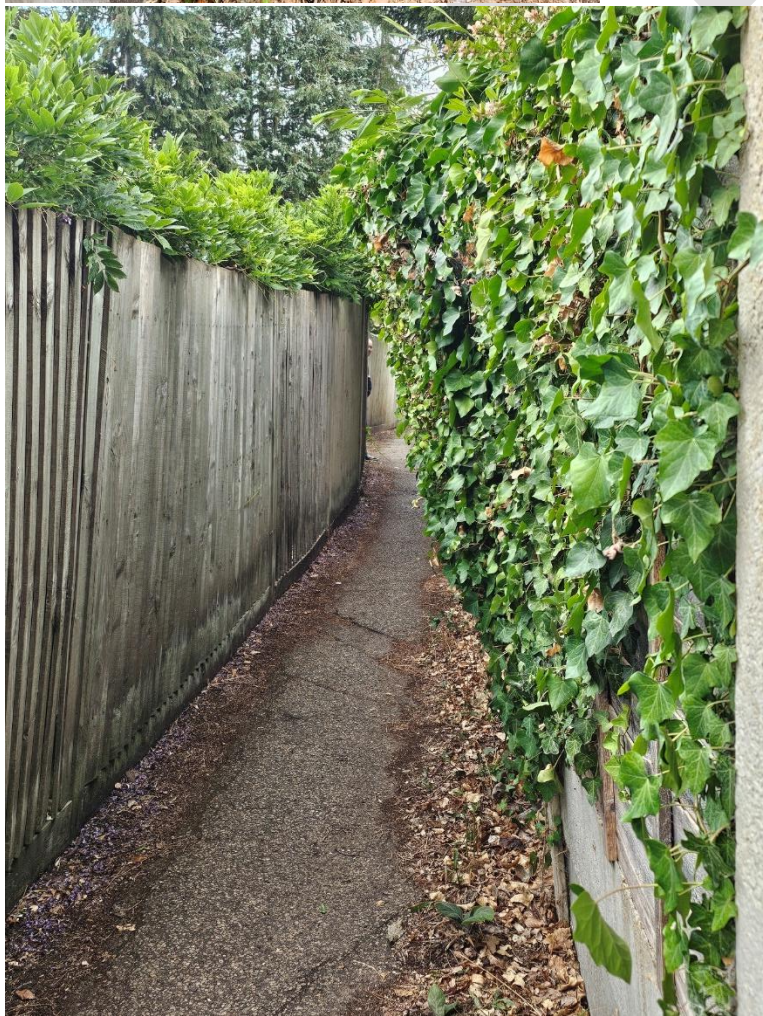
### **Ridgeway alleyway/Lovers Lane:**

- Lots of vegetation that has been cut back and simply left on the ground and is now dust
- Lumpy tarmac runs down the middle only
- Fence posts on the left make for concrete lumps on the path
- Fence leaning in
- Hole on footpath heading under fence
- Footpath not level
- Top part has mud in wet weather as the tarmac finishes where it meets Cleve Road
- The Ridgeway path sign needs to be repositioned higher

Mirror (reported), loose pavement edges, holes on Ridgeway Alleyway, uneven pavements

Fill alleyways full width with tarmac to even them out for all users and would make them wider.

- Do the walk again and note down exact locations of hedges, loose pavement edges and report accordingly.
- Speak to ridgeway officer about the alleyway, plus raise with property owner where fence invades path.
- Speak to highways about the raised tables. Does another village have them?
- Also Virgin Boxes got a mention – identify those that are problematic.
- Designate what can be solved and what cannot, and create a long term plan.
- Carry out a similar walk with different roads.

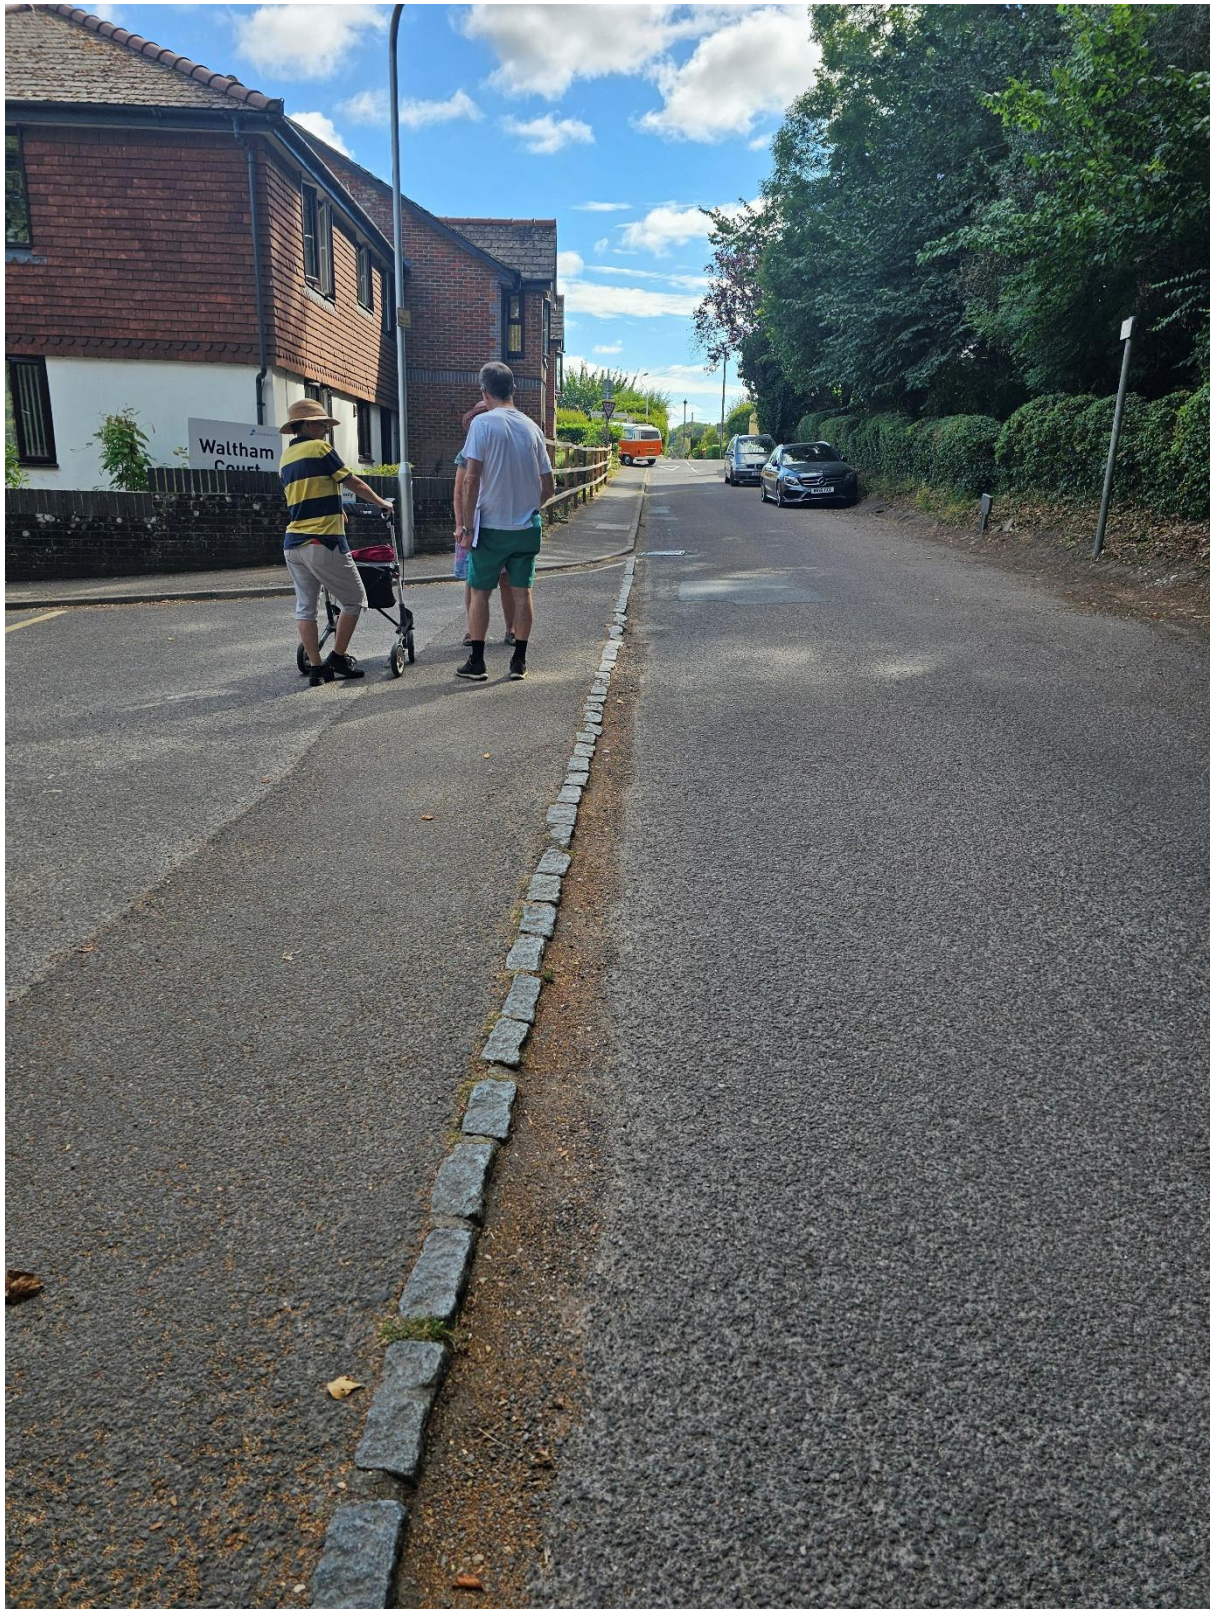
**Mill Road:**

Walkers need to walk in the road where there is no pavement, eg Cleeve Road and Mill Road. This is risky, especially with the vegetation making the usable road narrow.

Waltham Court does not have dropped kerbs where there is a pavement so continuing along Mill Road on the pavement is impossible.

Houses with overgrown or obstructive hedges, falling fences, to reclaim footpaths, council to deal with Mill Road vegetation.

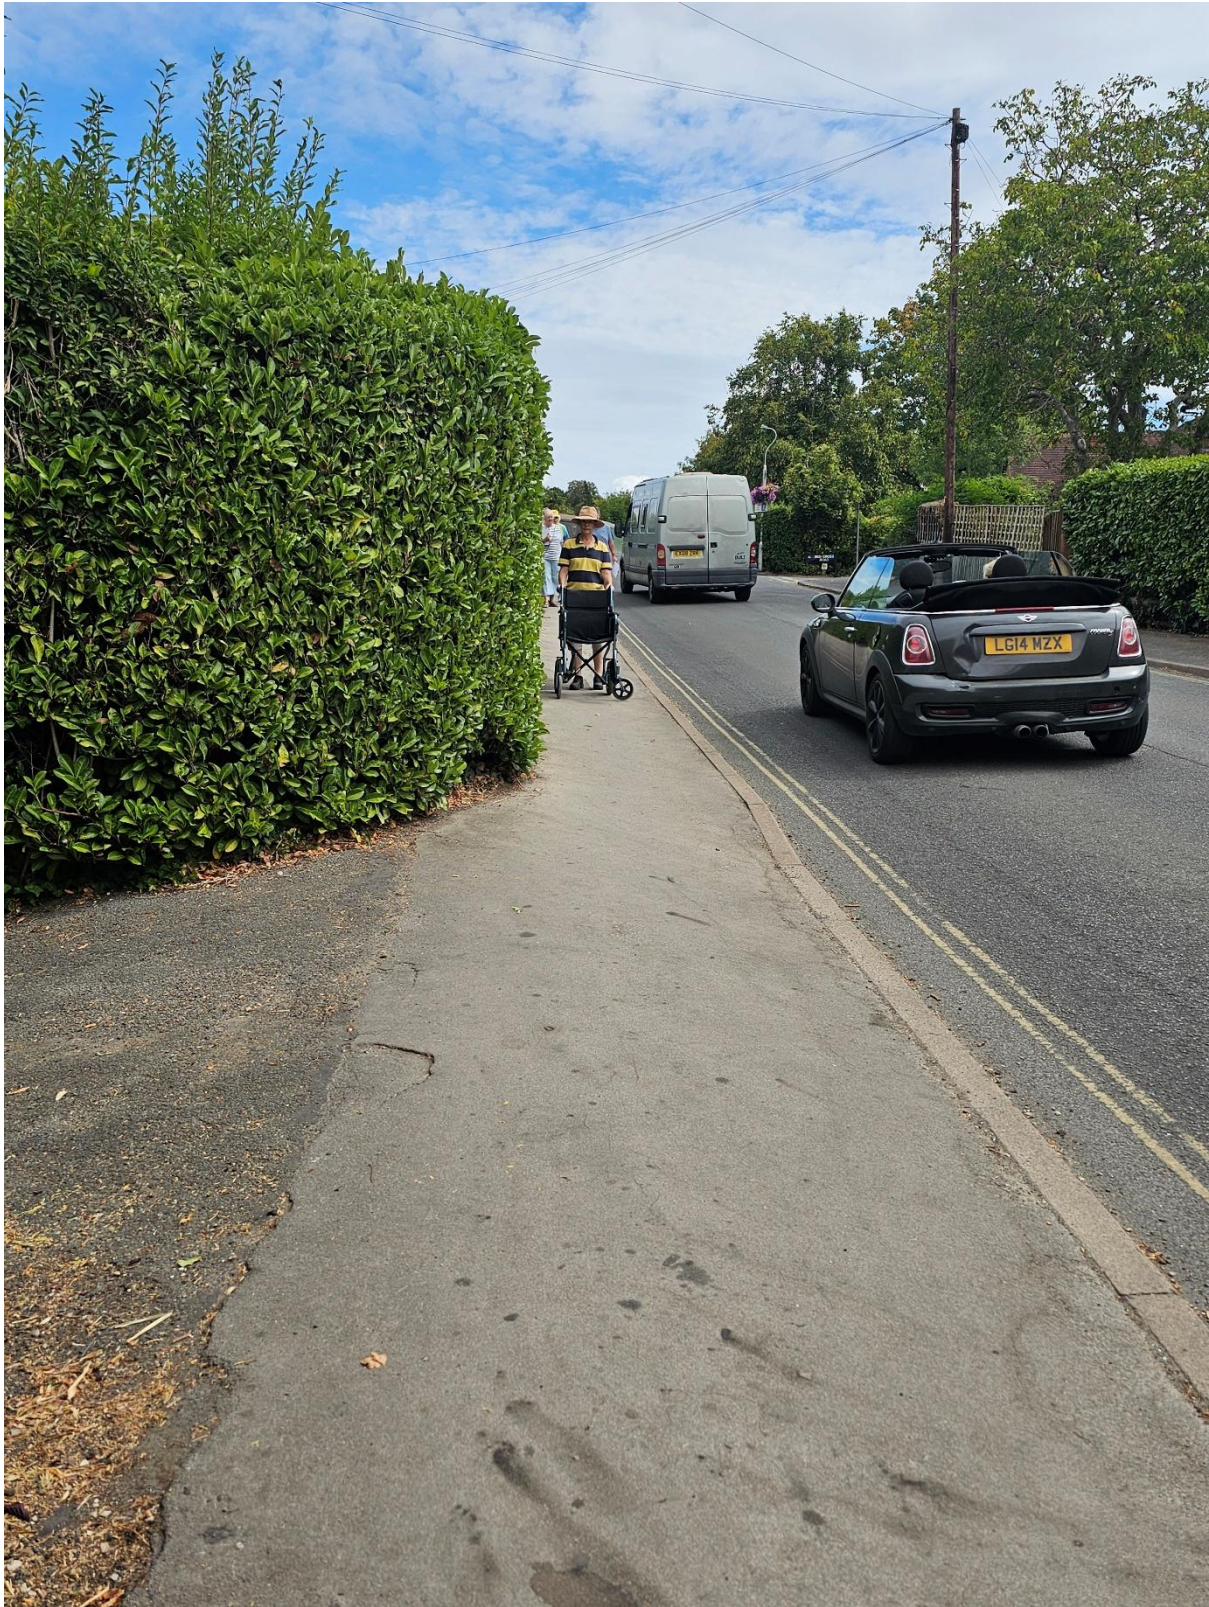
Area outside social club and shops/arcade:

The pavement disappears by before reaching Massooms, and the one on the other side is very narrow. There is no safe way to cross to it either.

Outside the Arcade is a clutter of signs which make walking an obstacle course, and more so if using wheeled assistance or sticks.
